THE OFFICIAL MAGAZINE OF THE NATIONAL DEMOLITION ASSOCIATION ■ JULY/AUGUST 2015

**SNOW  
PROBLEM**

**NDA MEMBERS AMERICAN DND INC.  
AND EMPIRE DISMANTLEMENT CORP. SAVE  
A BUILDING FROM COLLAPSE AFTER 70  
INCHES OF SNOW FALLS IN 72 HOURS**

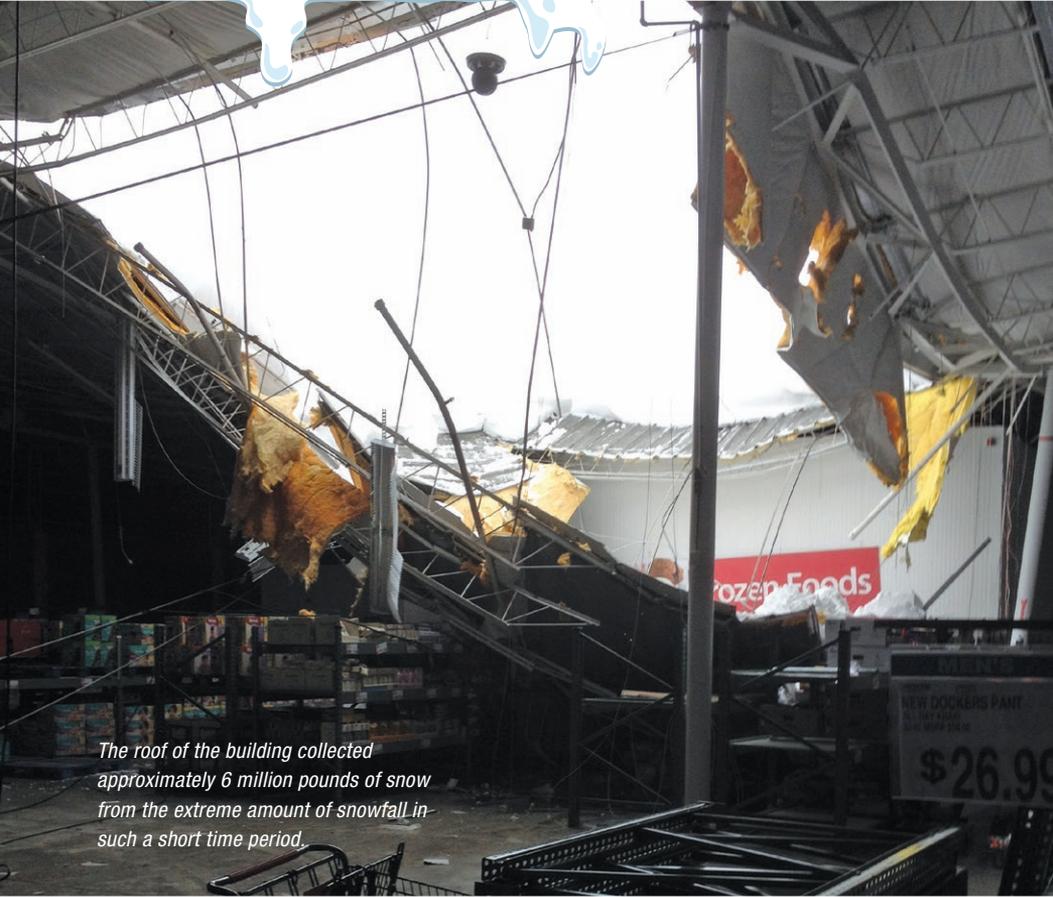
The roof of the building collected approximately 6 million pounds of snow from the extreme amount of snowfall in such a short time period.

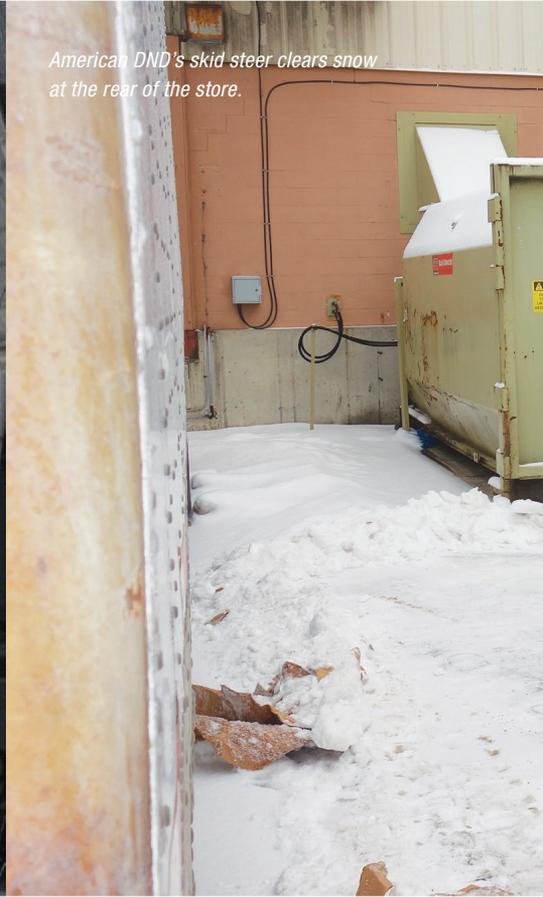
American DND's skid steer clears snow at the rear of the store.

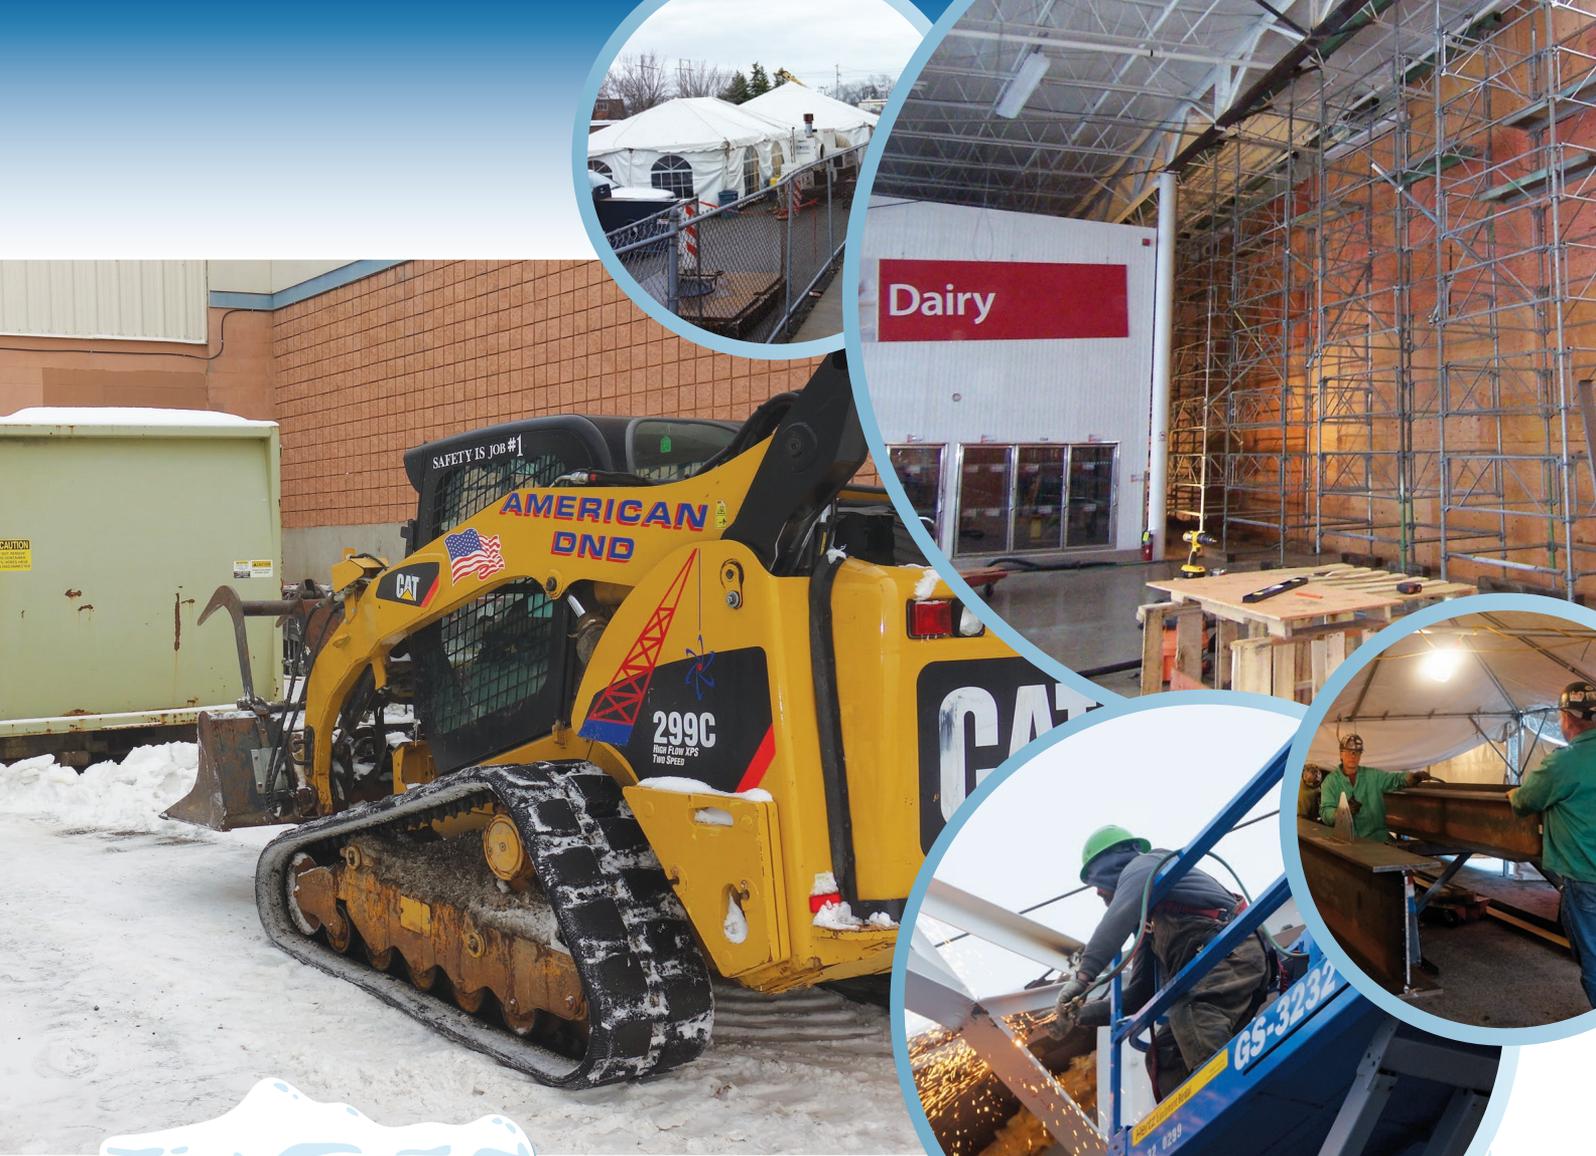
After the building was safe and secured, the project team was able to fully assess the structure's condition. A thorough

structural investigation determined that the building's existing construction contained numerous deficiencies, including missing lateral and diagonal bracing and various roof girder truss and bar joist deficiencies. The team was then challenged with dismantling the roof portion that had collapsed and straightening the building, in addition to fixing deficiencies from the original construction and rebuilding the structure to meet the new Building Code Roof Loading Criteria of 50 PSF versus the old Building Code of 30 PSF.

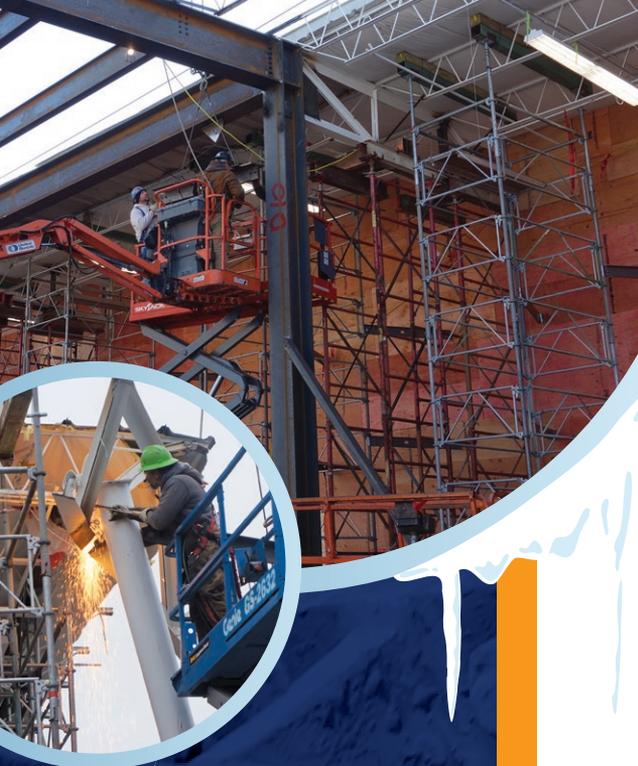
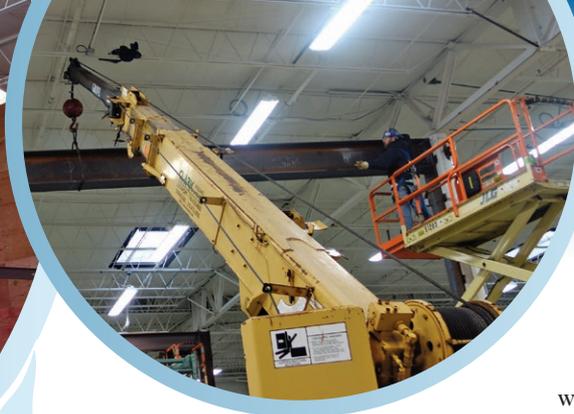
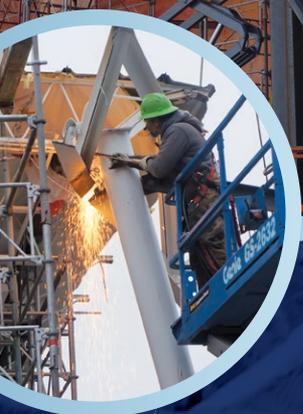
#### **CIRCULAR INSET IMAGES ABOVE, TOP TO BOTTOM:**

*A fabrication tent was set up on the job site.*

*More than 100 different 20,000-pound capacity shoring towers were installed throughout the project.*

*Crew members work to demolish the roof.*

The first order of business was to stabilize the entire structure and collapsed zone by shoring and bracing the roof and building columns in order to safely continue selective dismantling and to save millions of dollars in the club's inventory. More than 100 different 20,000-pound capacity shoring towers were installed throughout the project, in addition to diagonal cabling and turnbuckles to stabilize and secure the building from future collapse and progressive failure.

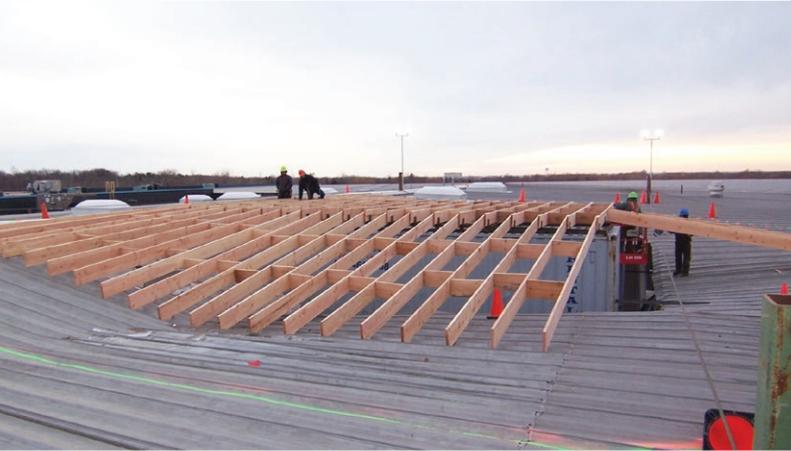
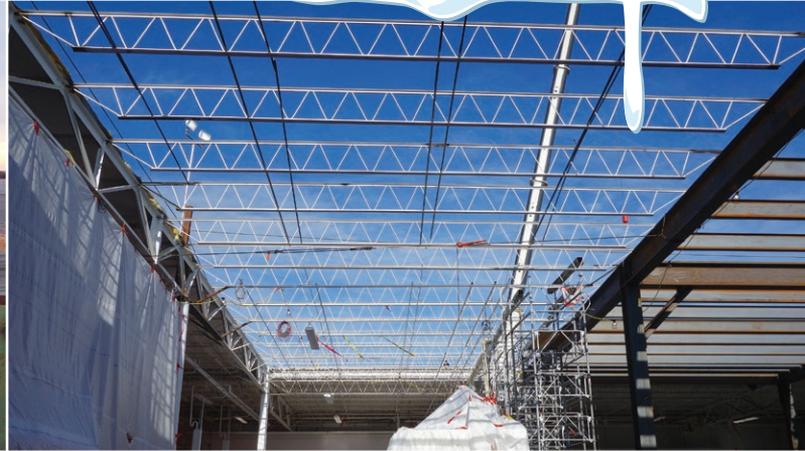
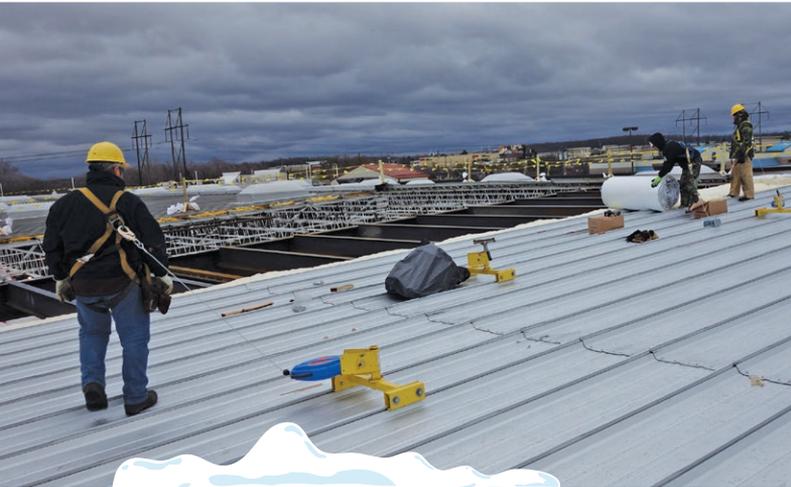
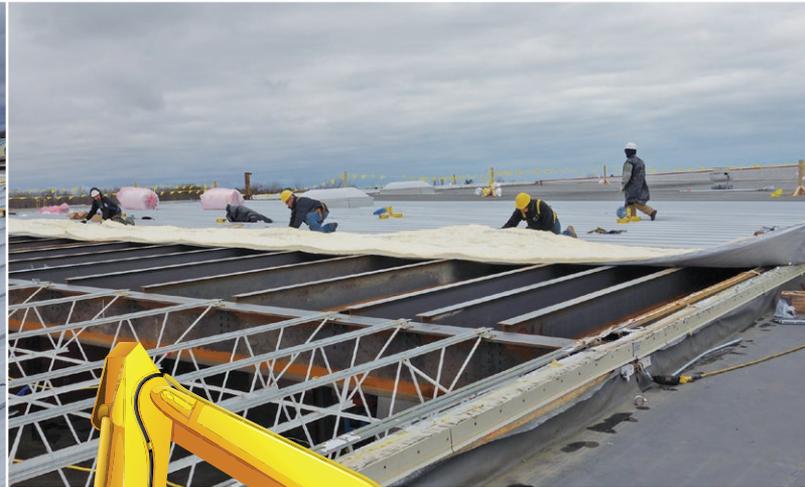
*The project also involved life, fire and safety concerns regarding the sprinkler system and fire protection during the dismantling and reconstruction work.*

The fire sprinkler system was temporarily reworked from three zones down to two

in order to reactivate the system and provide active fire protection to the entire structure. Numerous walk downs and inspections with the local fire departments and town fire marshal provided open and transparent communication with all stakeholders; helped mitigate fire loading in the building; and kept the project safe for the construction workers and all other plaza occupants throughout the entire project.

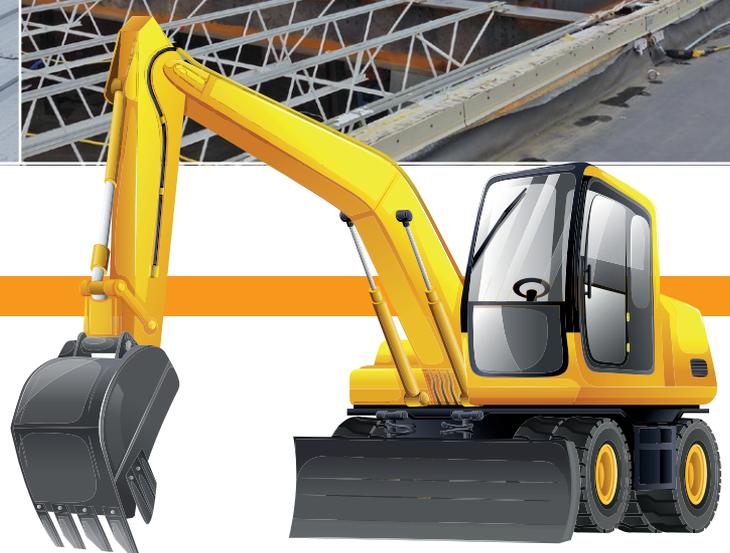
A 400 ton hydraulic crane with up to 300 feet of boom was on-site, along with smaller cranes and material handlers to help with moving around and placing the steel columns and beams weighing up to 3 tons each.

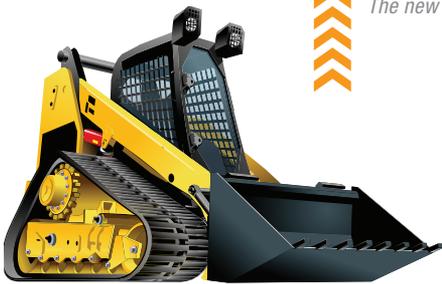
*The project team achieved its safety goal of zero OSHA Days Away, Restrictions and Transfers (DART) and zero Lost-Time accidents.*
